# Morphological Changes in Teesta River Basin: Impact and Adaptation Strategies in the Northern Bangladesh

**PhD Dissertation**

**Department of Geography and Environmental Studies**

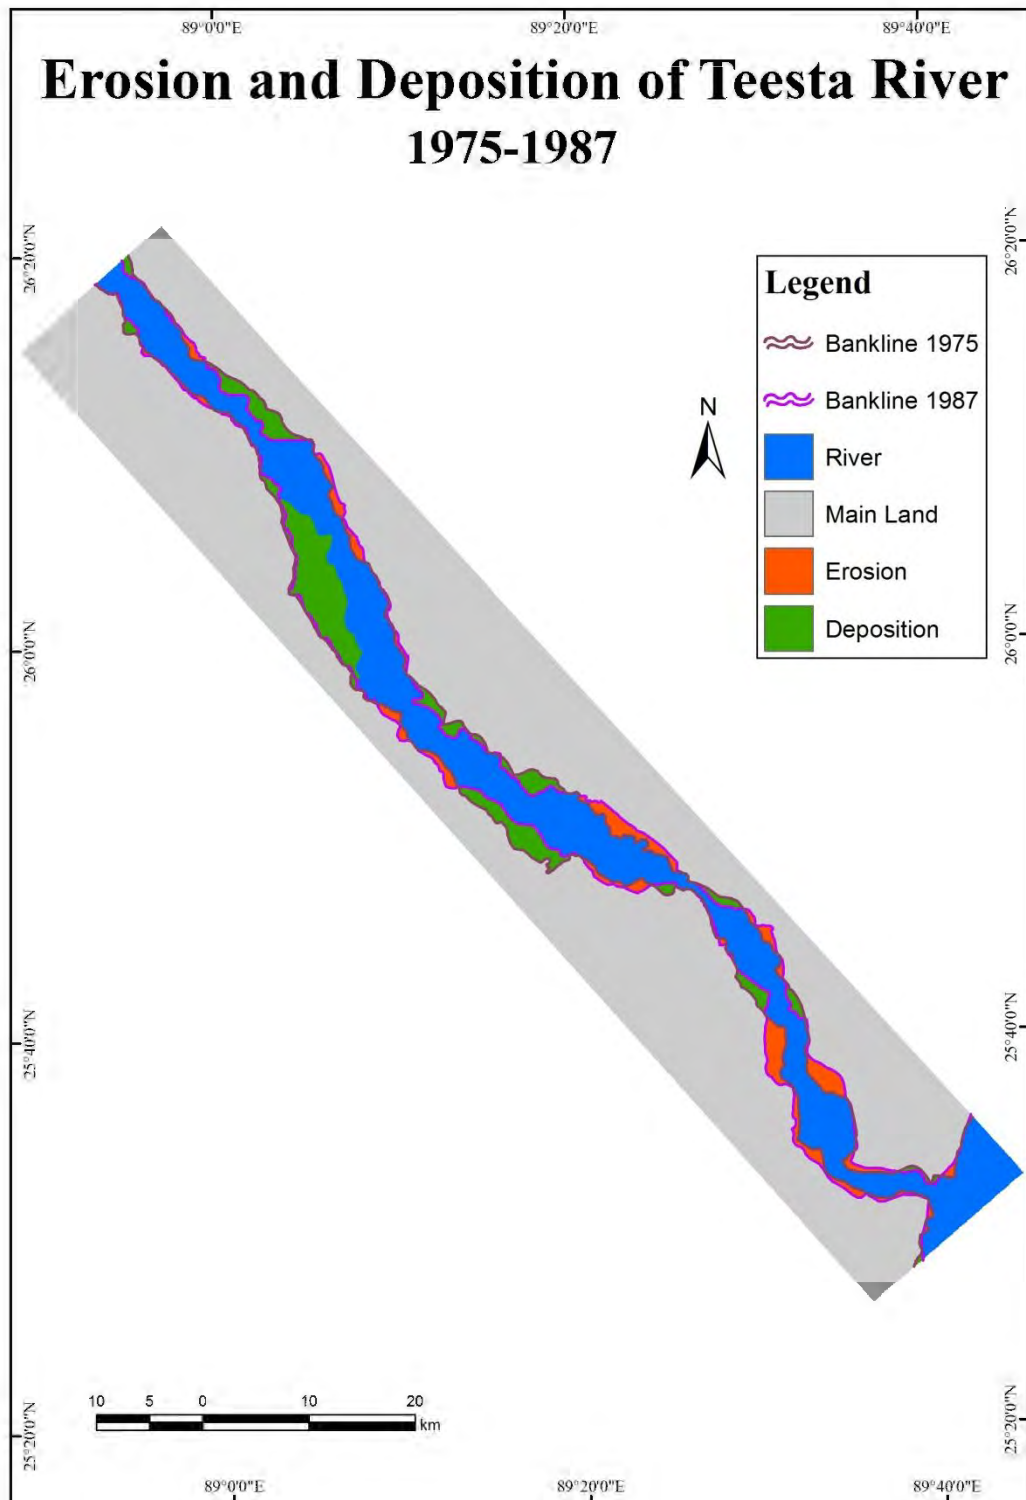
Map 5.2 Bank erosion and deposition of Teesta (1975-1987)

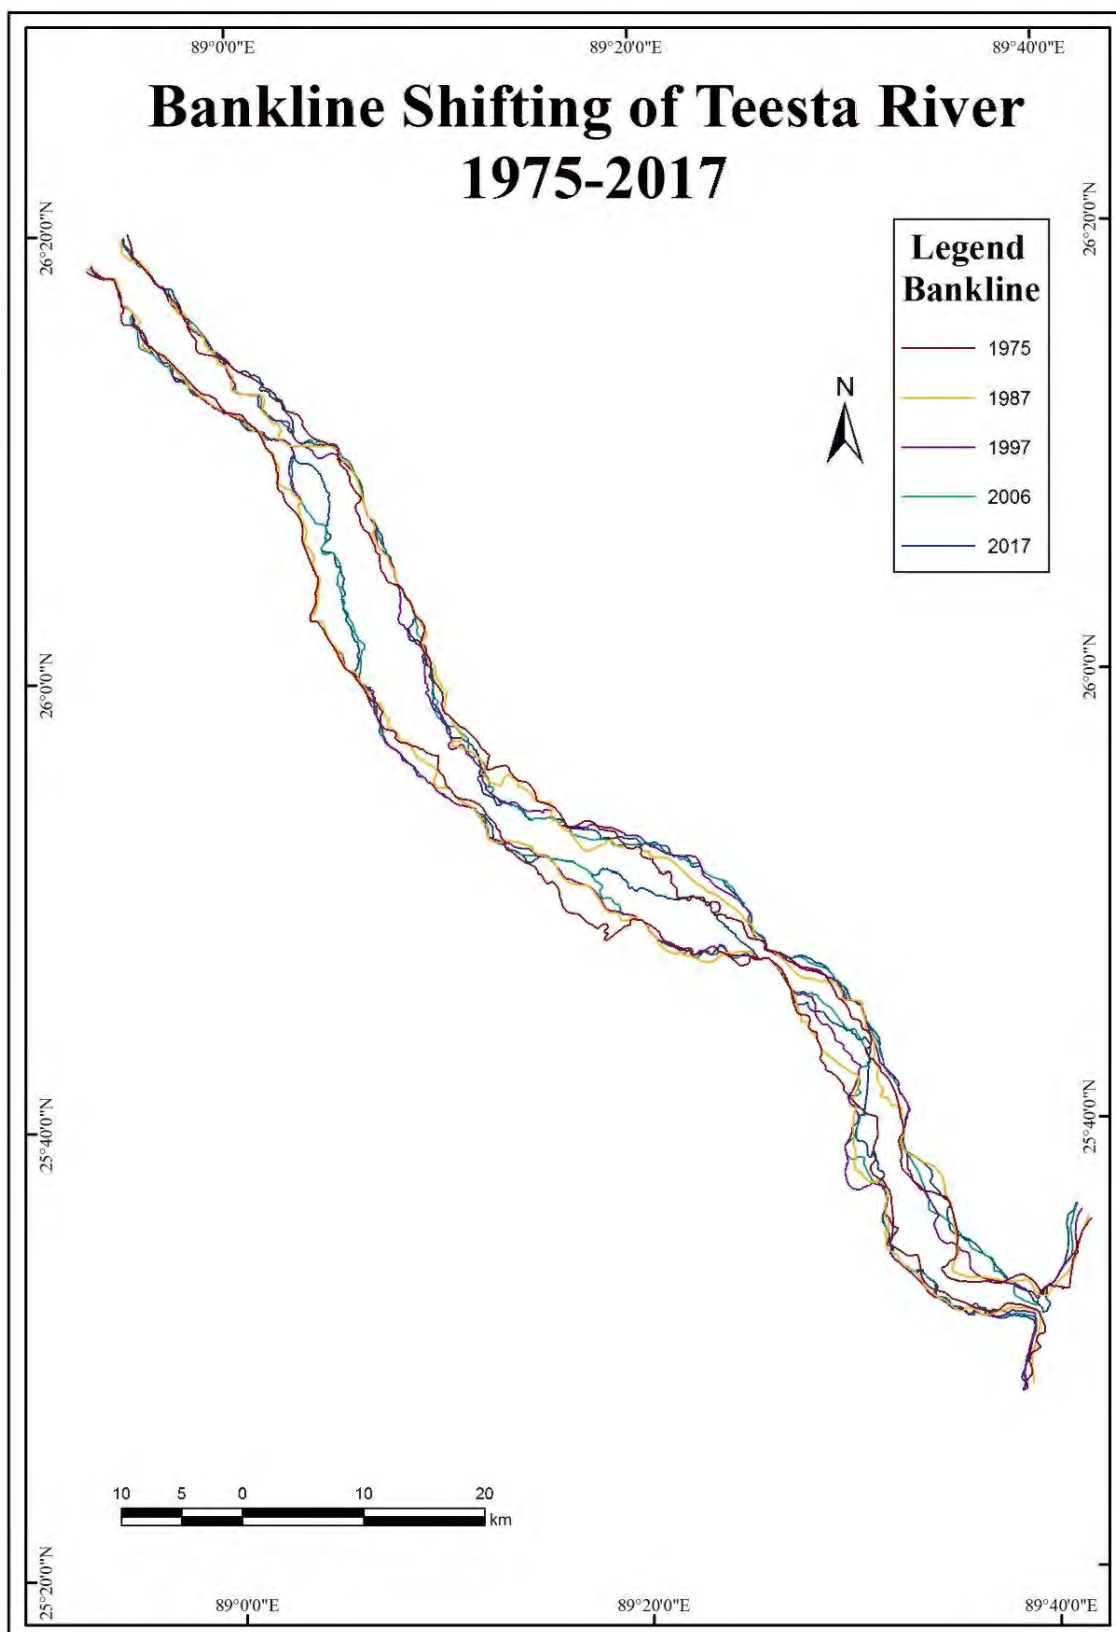
River bank erosion and sediment deposition in bank causes the change in river width as well as bank line shifting or channel migration. Channel widening occurs in the Teesta river due to extreme flood and 8.1% large area has been detected in Teesta in 2010 than 1930s (Prokop and Sarker, 2012). To detect the river width, the river has been segmented through nine width measuring line and labeled from A-I. Table 5.3 indicates the width of Teesta river in the study decades. In 1975, segment G shows lowest width (0.74 km) and segment C shows highest width (7.46 km). The highest width (7.21 km.) in 1987 has been also depicted in segment C and lowest in segment G (0.73 km). The Teesta river denotes

**Map 5.7 Bank line shifting and channel migration (1975-2017)**

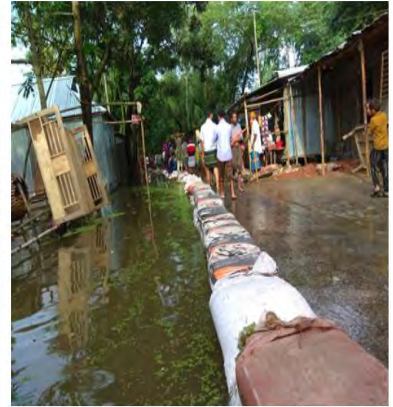
8. c) Sand bag piling for flood protection
